1994 Northridge Earthquake

Performance of Structures, Lifelines and Fire Protection Systems

NISTIR 5396

March 1994
Building and Fire Research Laboratory
National Institute of Standards and Technology
Gaithersburg, MD 20899

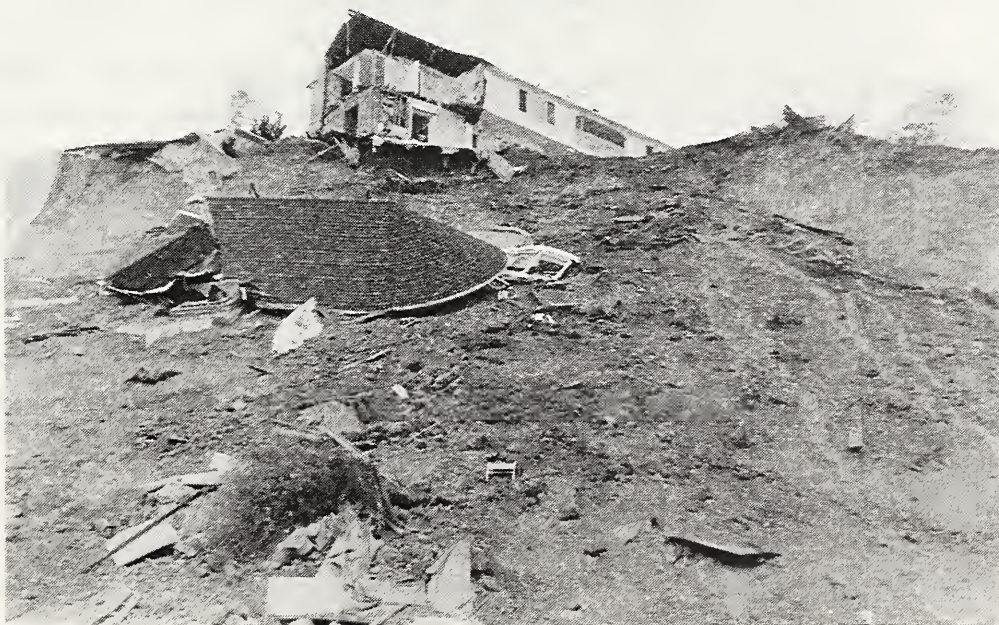
Figure 2.8 A landslide along the Pacific Coast Highway north of Santa Monica undermined the foundation of a house at the crest of the slope, bringing a portion of the house down.

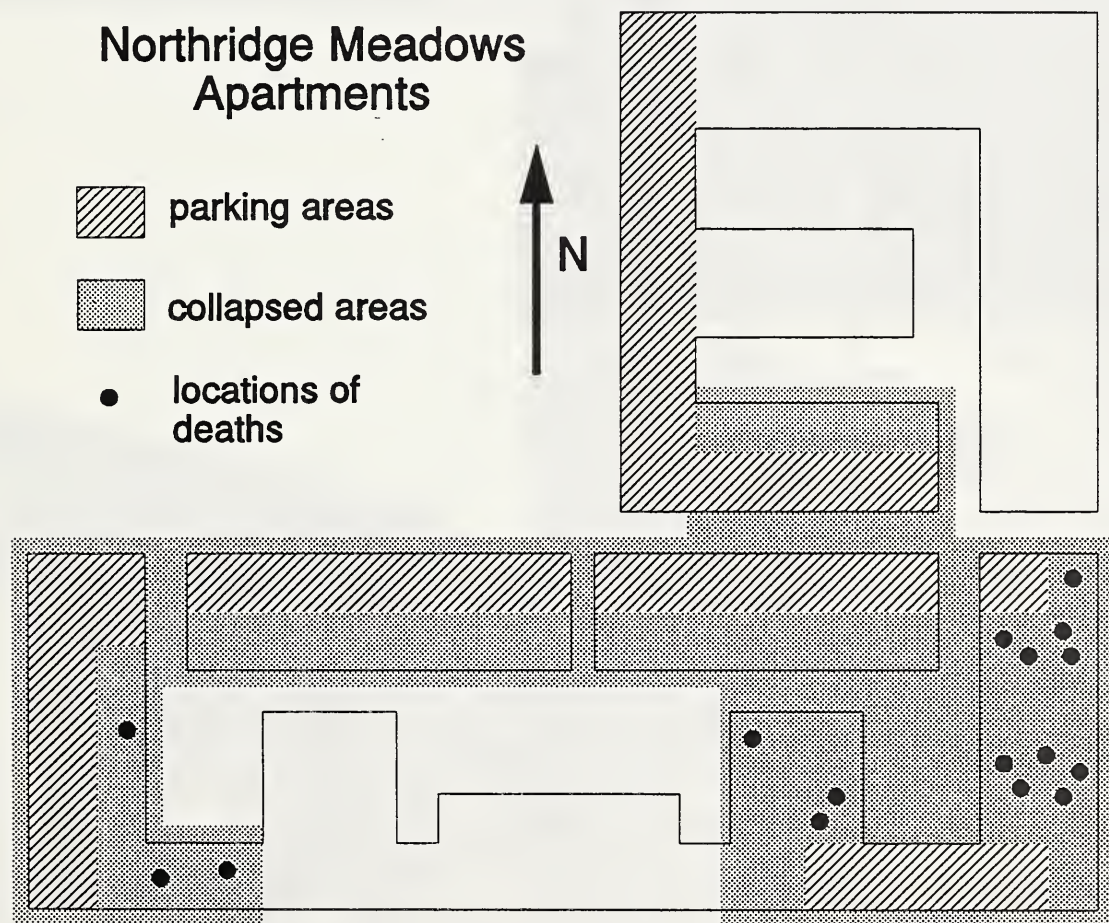
Collapses in a single apartment complex caused sixteen of the twenty-two deaths related to building failures (Los Angeles County Coroner, 1994). The Northridge Meadows complex, constructed in 1972 (Los Angeles Times, January 19, 1994), consisted of several three-story wood-frame buildings, arrayed around courtyards on two sides of a mid-block alley. About half of the units had open spaces for parking on the street level. Typically these were around the perimeter of the complex. Most of the interior courtyard-facing units had living space at the ground level rather than parking. About half of the buildings in the complex collapsed. In all of the collapses, the first story gave way while the second and third stories remained largely intact. The sixteen people killed were in first story apartments. All the buildings in the complex suffered some damage (Figures 3.3 and 3.4).

Figure 3.3 This plan of the Northridge Meadows apartment complex shows the distribution of parking and living spaces at the first level, and locations of deaths (source: Los Angeles Times, January 24, 1994). The shaded areas indicate the portions of the complex which collapsed.

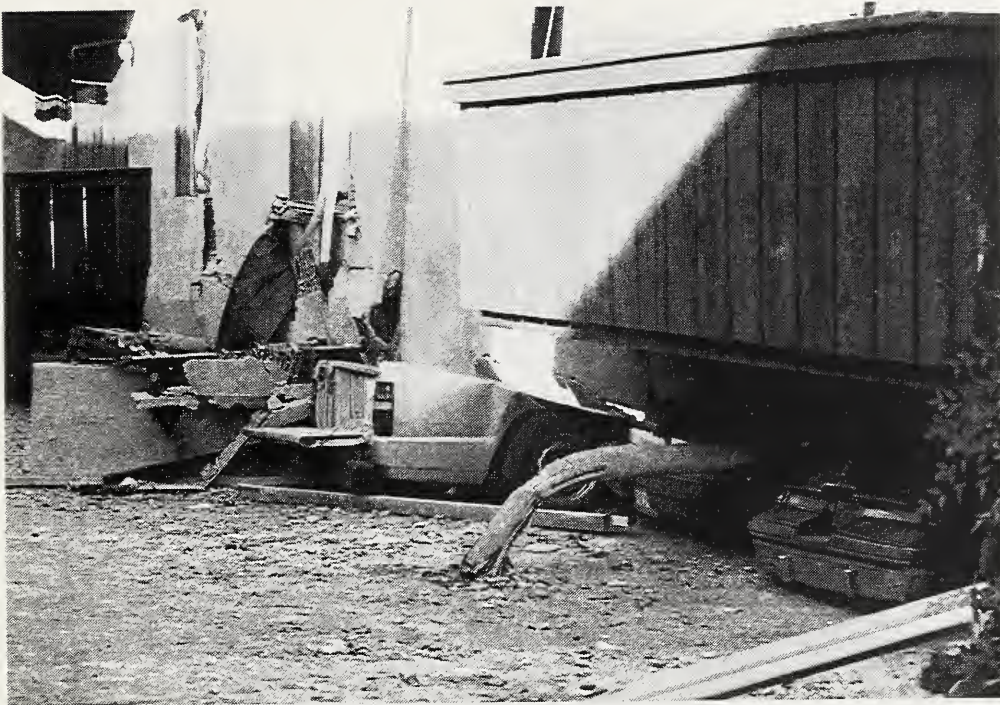
The upper stories of the collapsed buildings were displaced laterally and in some cases came to rest offset by as much as three meters from their original locations. The steel pipe columns, which hinged at their bases, apparently controlled the distance of the offset as they bent to the ground under the load of the building above (Figure 3.6). Collapses occurred in buildings aligned longitudinally east-west as well as those aligned north-south. At the southeast end of the complex, some building portions collapsed to the north, and other portions collapsed to the south, which indicates that no one extreme pulse of energy brought all the buildings down.

Figure 3.6 At Northridge Meadows, the first story steel pipe columns generally hinged near their bases but retained their length, controlling the displacement of the upper stories.

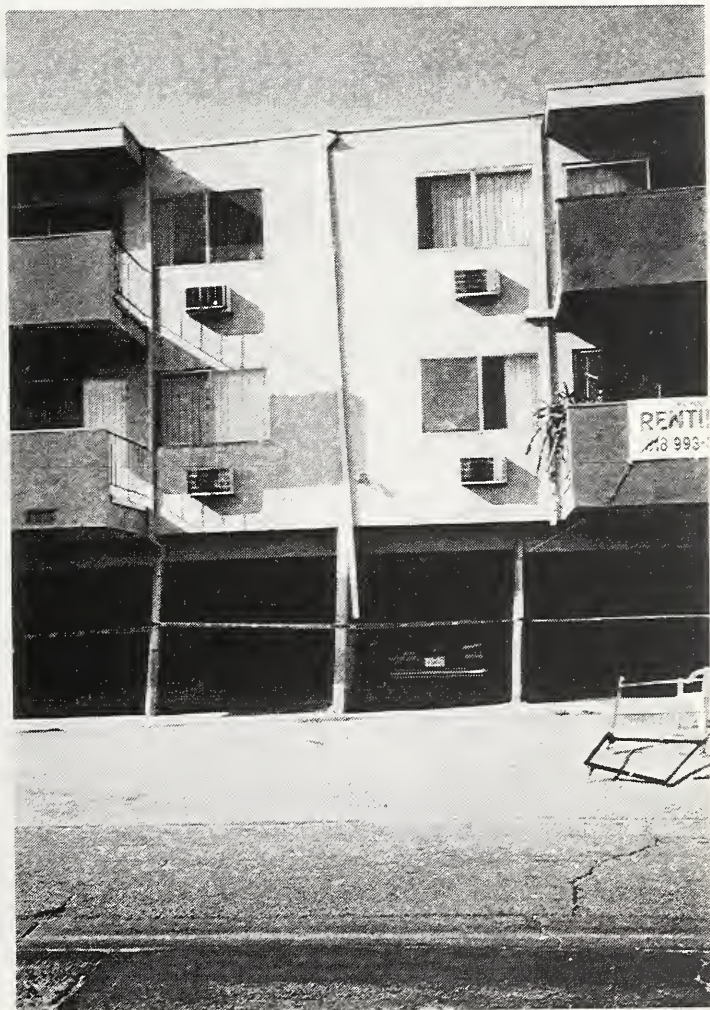
Figure 3.7 Racking, or leaning, of open first story parking areas was a common feature of damaged two and three-story apartment buildings.

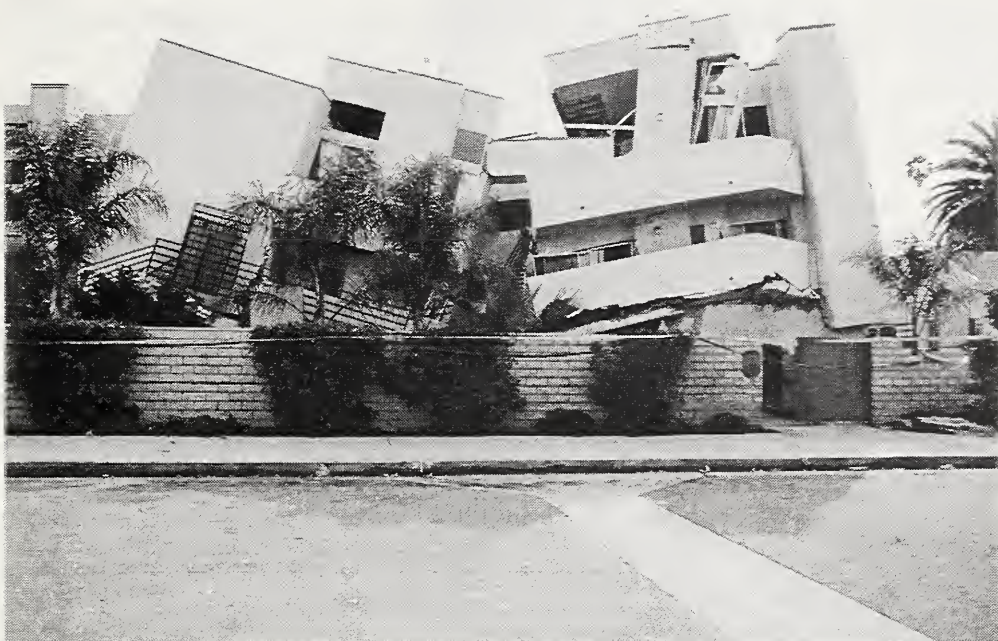
A more unusual collapse occurred in an apartment building of more recent vintage with the entire first story used for parking, located on Sherman Way in Sepulveda. In this building, the first story parking area was open only on the transverse ends. Concrete block walls formed the longitudinal walls at the first story and a row of concrete columns supported the mid-span of the flat plate concrete floor slab above. The two stories of living space over the parking level were wood-framed with a stucco facade. The entire line of mid-span concrete columns failed. The two halves of the upper stories settled in towards the middle (Figures 3.10 and 3.11), essentially destroying the structure.

Figure 3.10 The central row of concrete first-story columns in a three story apartment building on Sherman Way in Sepulveda collapsed, causing the wood-framed upper stories to settle inward.

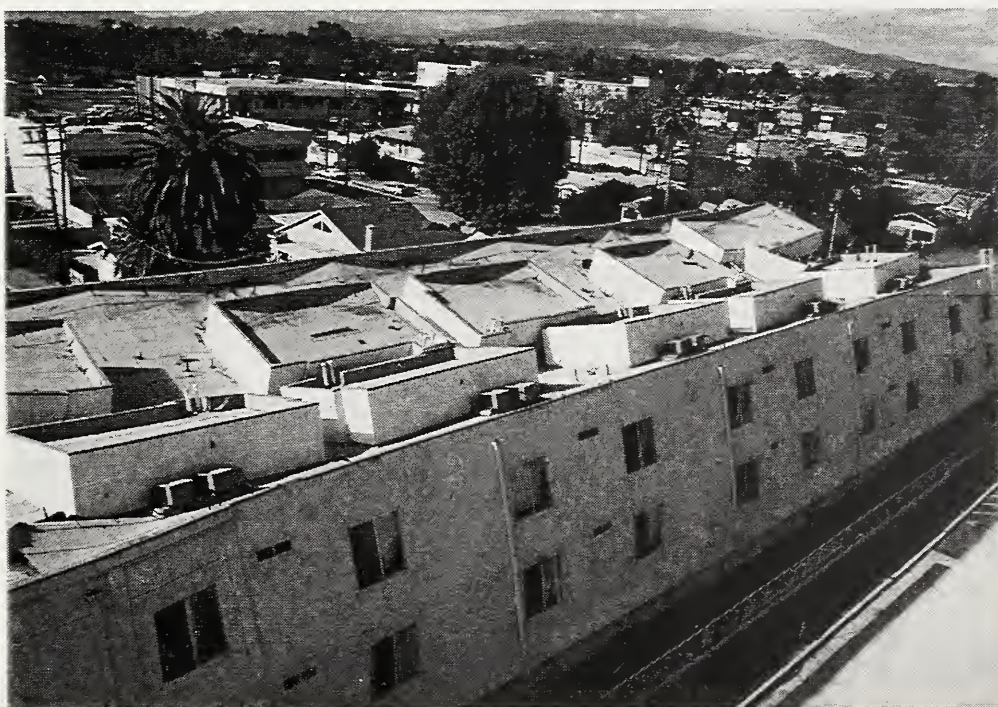
Figure 3.11 This overhead view of the partially-collapsed apartment building on Sherman Way shows the solid concrete masonry block perimeter walls along the longitudinal axis of the building. Access to the first story parking was limited to the transverse ends of the building. When the row of interior columns failed, both sides of the building settled in towards the middle.

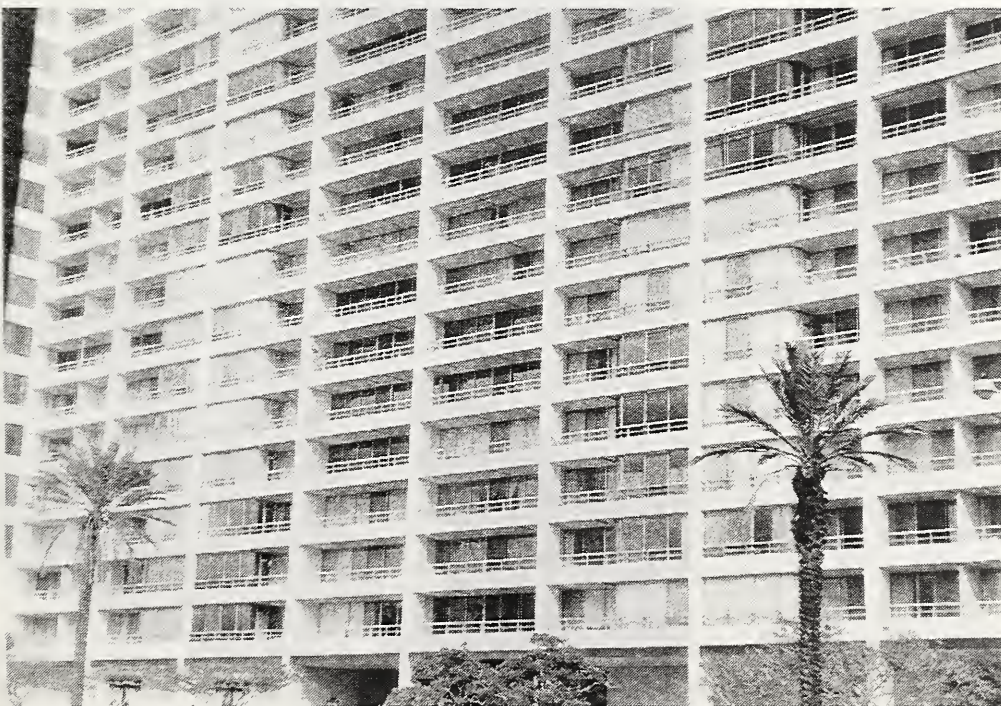
In the longitudinal direction, the lateral-force resistance is apparently provided by concrete moment frames. The front of the building shows no sign of damage (Figure 3.13). At the back, the columns and transverse wall ends are diagonally cracked (Figure 3.14). Doors in the transverse walls and open passageways connect the spaces behind these cracked columns in the middle third of the building (Figure 3.15). The solid infill railings which rise to about mid-height of the columns create an unintentional "short-column" effect. The solid railings made the bottom half of each column extremely rigid. This forced the top half of the column to accommodate all of the differential movement between stories. These shortened columns, apparently not detailed to accommodate the motion, failed in shear. At the front of the building, metal pipe railings are provided at the balconies rather than solid infill, as at the back. This may partially explain why there is no apparent damage at the front of the building.

Figure 3.13 The front of the 16-story Champagne Towers building had no apparent damage. Note the steel pipe railings at the balconies.

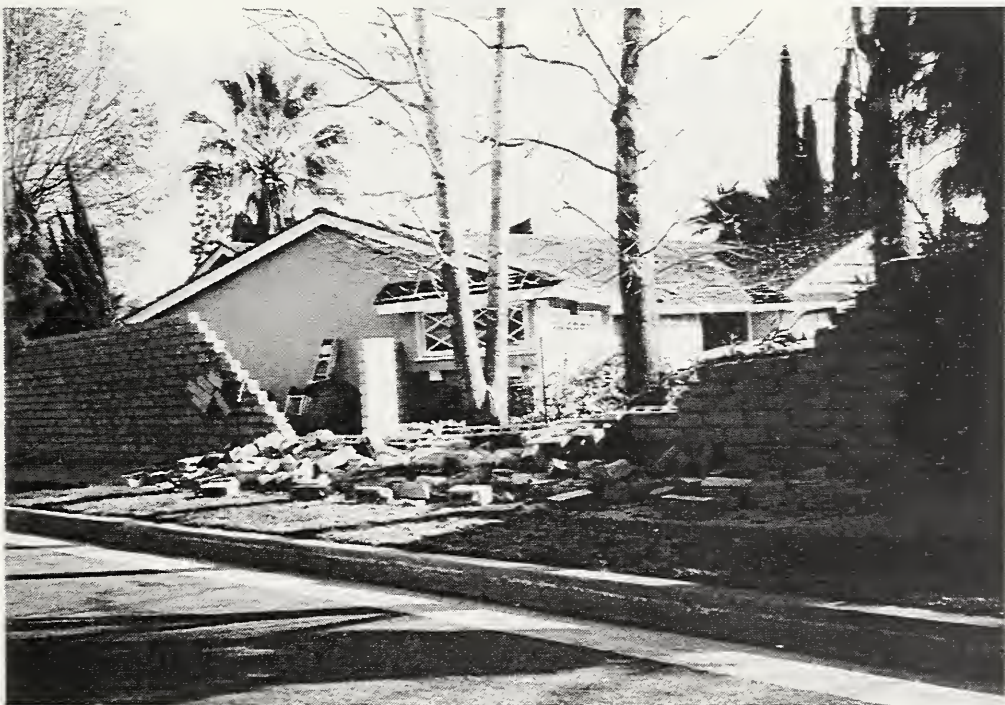
Figure 3.18 Damage to masonry privacy fences was ubiquitous. Many of these fences were tall enough to have been a serious threat to passersby when they failed. Luckily, due to the early morning hour of the quake, yards and sidewalks were essentially deserted.

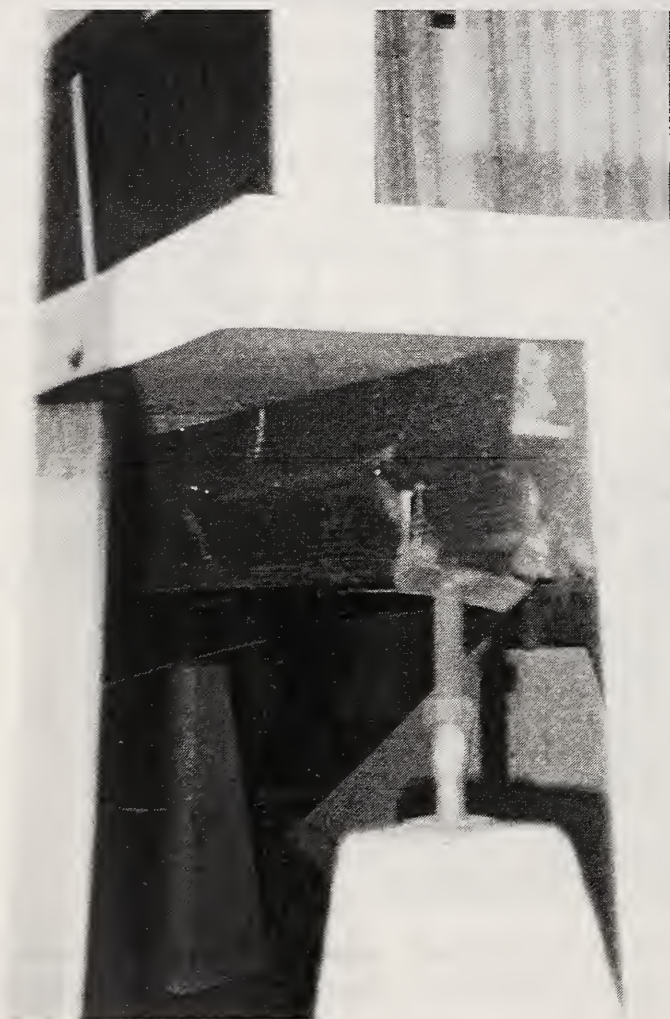
The vulnerability of mobile homes to earthquake ground shaking was demonstrated once again by the Northridge earthquake. For example, in a trailer park near the epicenter, at the intersection of Nordhoff Street and Tampa Avenue, nearly every home had moved on its supports. These types of homes are usually supported on small concrete and metal base supports (Figures 3.19, 3.20, and 3.21). These supports provide little resistance to lateral movements, and toppled during the quake (Figure 3.22). The identical failure was observed in the 1971 San Fernando earthquake. It is clear that no improvements in the practice of supporting manufactured homes adequately against lateral loads have been made during the past twenty-three years.

Figure 3.20 Small concrete base supports
are a common foundation system used to
support manufactured housing. This type
of system provided little resistance to
lateral forces.

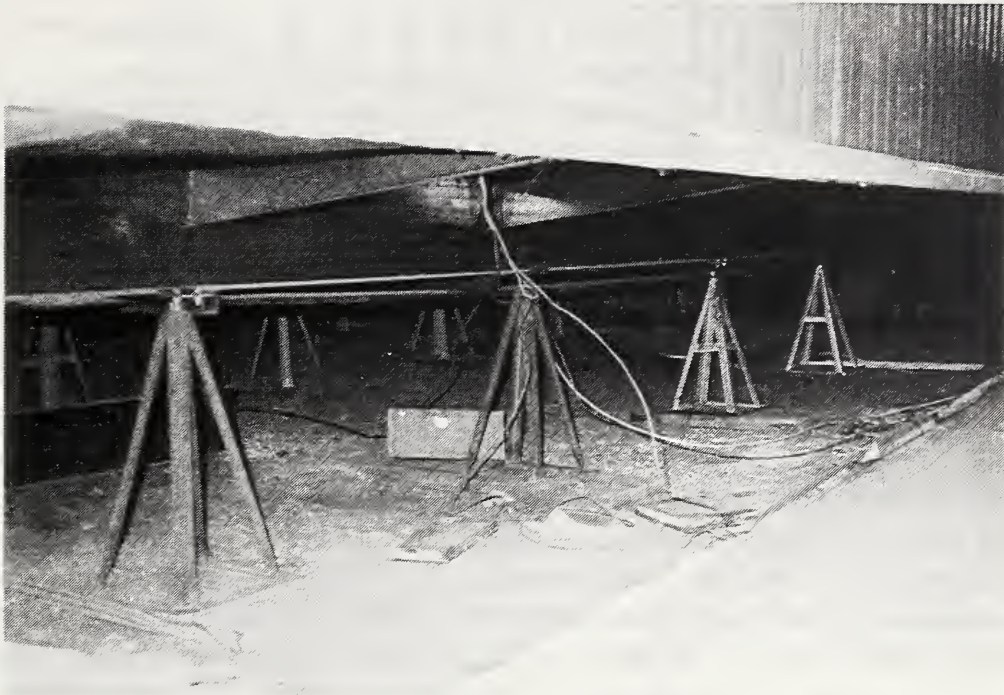
In some cases, the metal base supports were braced with small steel angle members. However, they were not adequately fastened to the supports and did not prevent the supports from rocking.

Figure 3.21 Another foundation system used for manufactured housing consists of supports constructed of small metal angles.

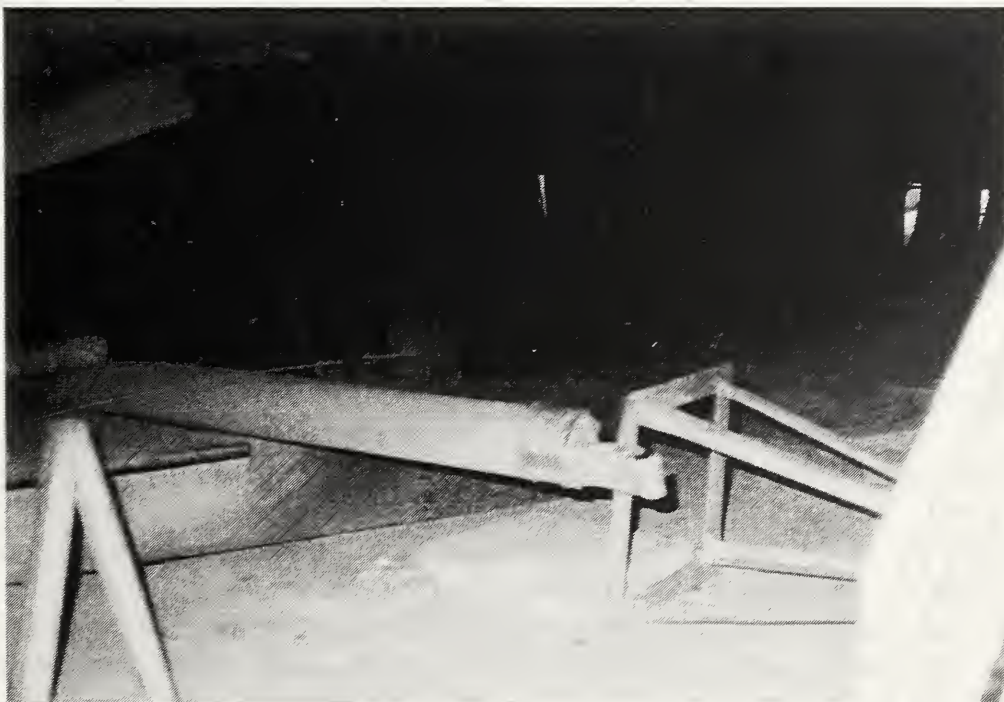
Figure 3.22 The metal supports under many homes tipped over, bringing down the houses above.

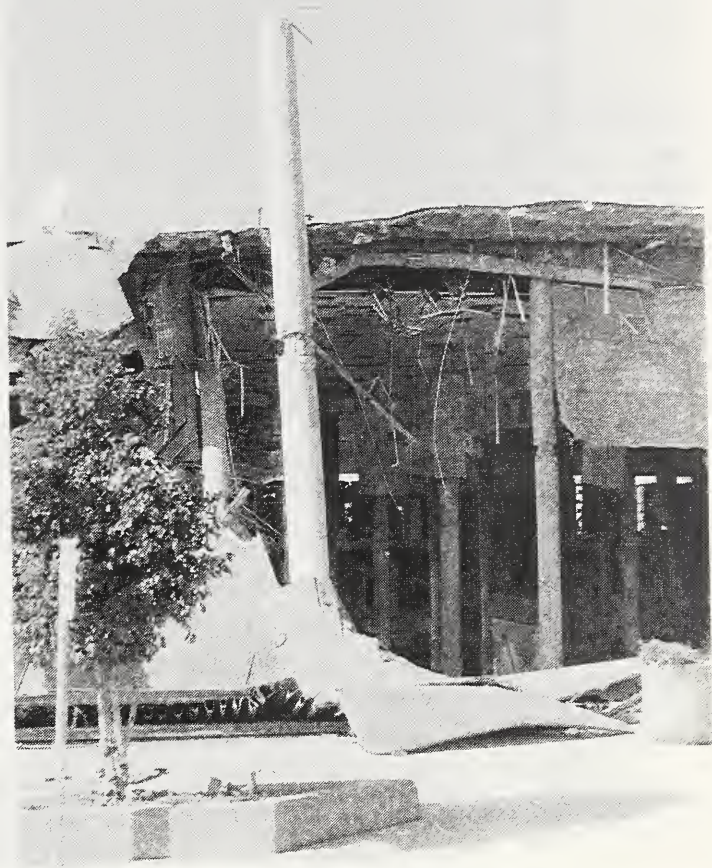
Figure 3.30 The Bullock's department store had an extremely irregular vertical geometry. At the northeast end it was shaped like a truncated pyramid.

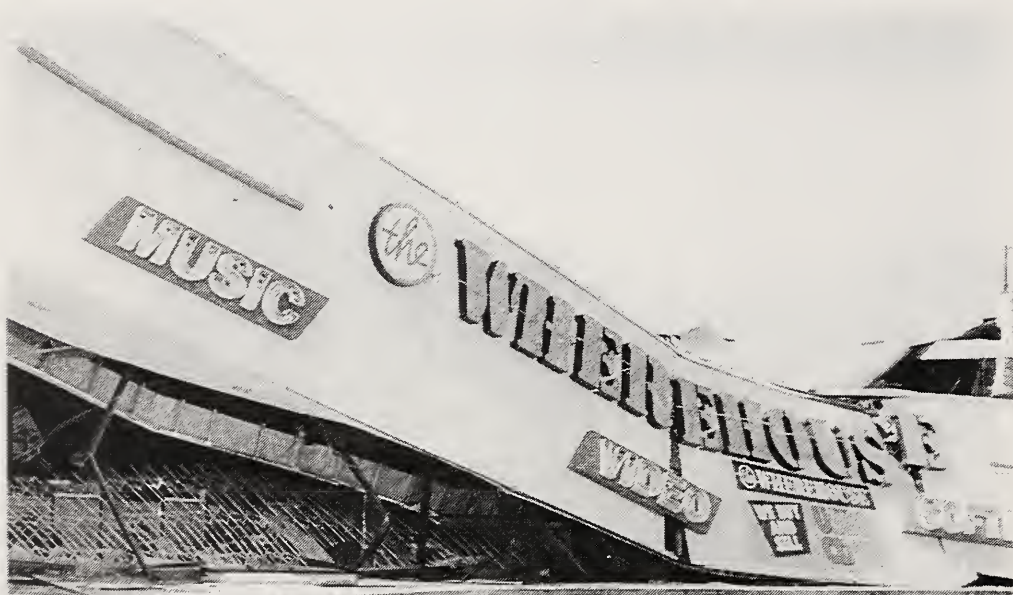
The area around the Northridge Fashion Center showed evidence of having been severely shaken. Significant damage of many types occurred. South of the Northridge Fashion Center, several single story retail structures were damaged; at least one, the Wherehouse, collapsed (Figure 3.32).

Figure 3.32 Many commercial buildings were damaged in the blocks south of the Northridge Fashion Center. The single-story Warehouse collapsed completely.

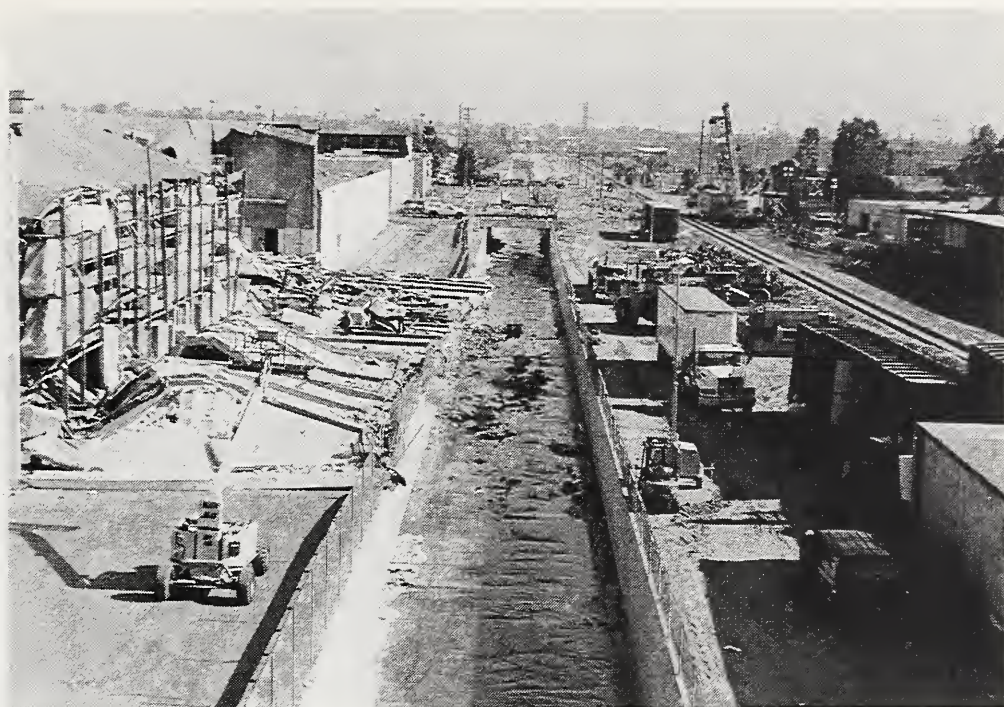
Figure 3.33 The south wall of the concrete tilt-up Levitz furniture store/warehouse south of the Northridge Fashion Center fell away from the building into the alley and stream channel. The damaged roof was being supported by the racks of furniture. On the south side of the stream channel a freight train derailed during the earthquake. That clean-up effort was still underway three days after the quake.

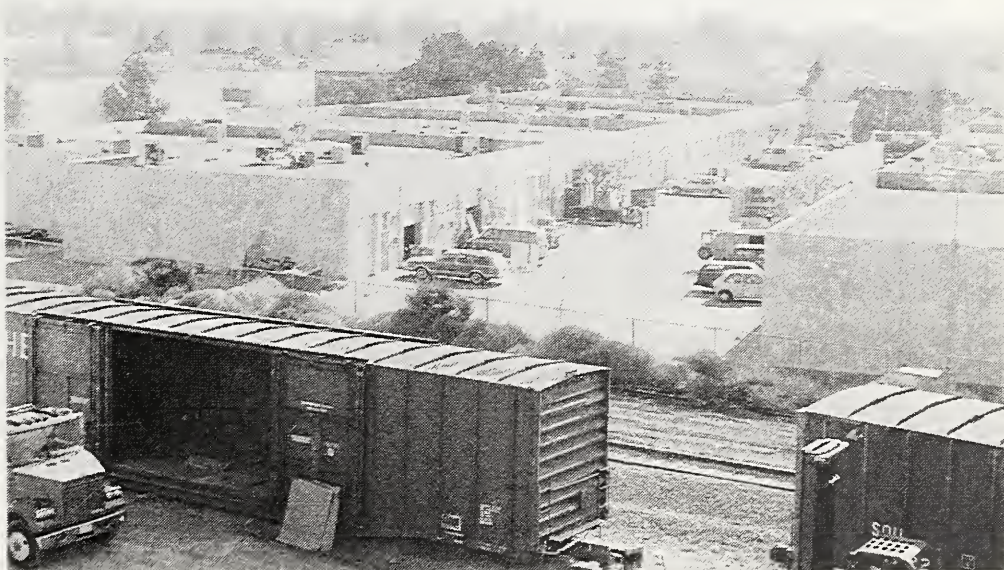
Figure 3.34 The single-story modern masonry commercial buildings directly south of the damaged Levitz furniture store and train derailment were apparently undamaged. All parapets and piers between garage openings appeared intact.

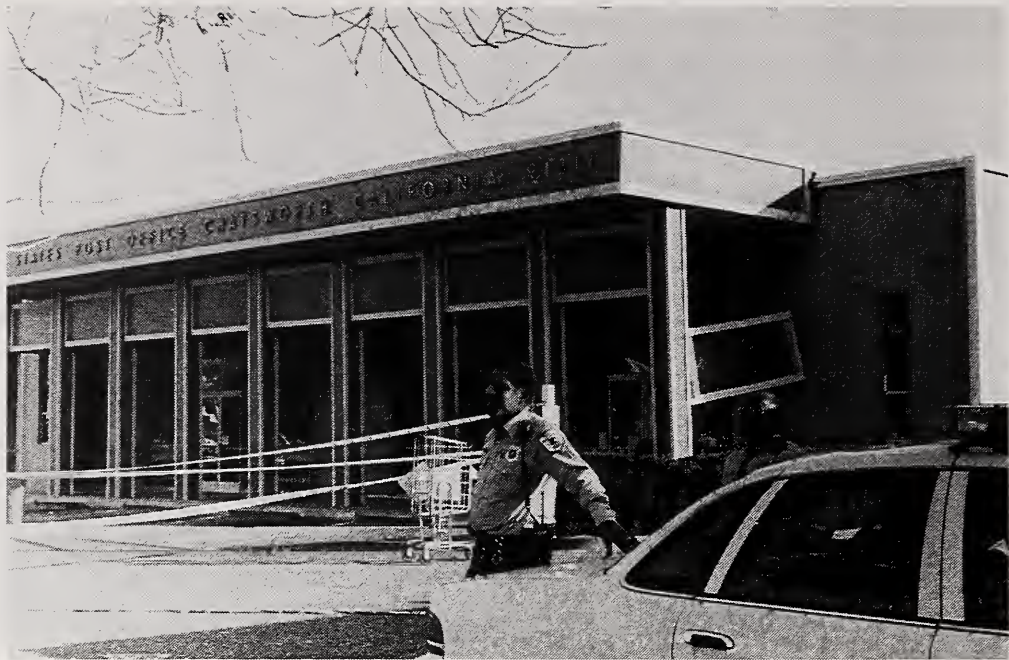
facade panel had become detached and interior ceiling panels had fallen (Figure 3.35). Mail was being collected in the parking lot.

Figure 3.35 The Chatsworth Post Office was closed due to damage. Mail was being collected in the parking lot.

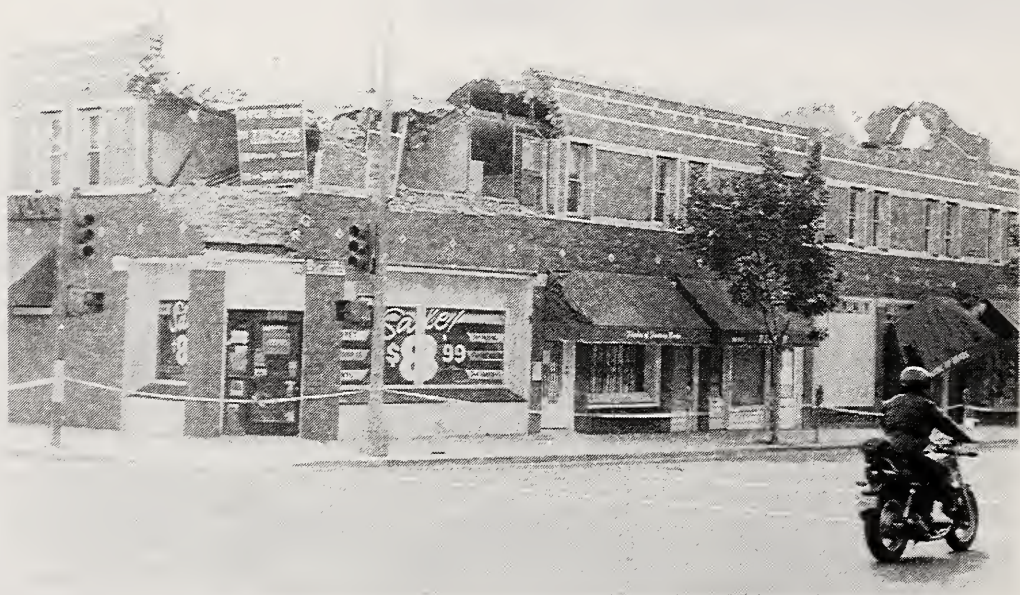
Figure 3.36 Damage to unreinforced masonry buildings, even those that had been rehabilitated, was common. Upper stories and corners were particularly vulnerable to damage. The rows of light-colored diamonds on the face of this building are the end plates of through-bolts used to connect the wall to the floor joists, a typical rehabilitation technique. The remains of parapet braces can be seen on the roof.

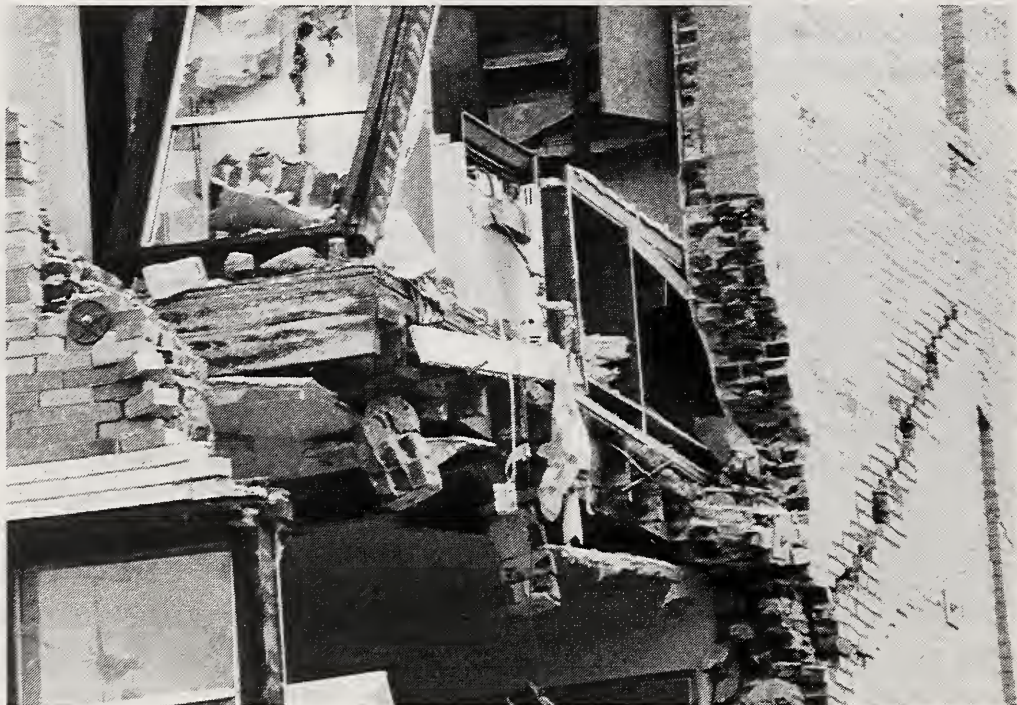
Figure 3.38 A close-up view of the third-story floor diaphragm of the building picture above shows (lower right) a rehabilitation bolt still holding a few bricks to the floor joists, after all the walls on three out of four sides of the bolts had disintegrated.

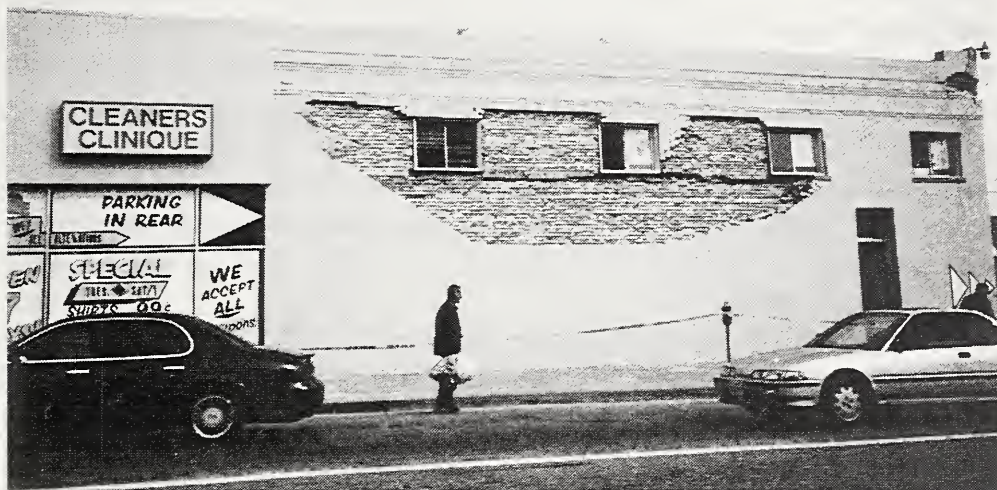
Figure 3.39 Only the exterior wythe of brick peeled off of this rehabilitated unreinforced masonry building in Santa Monica.

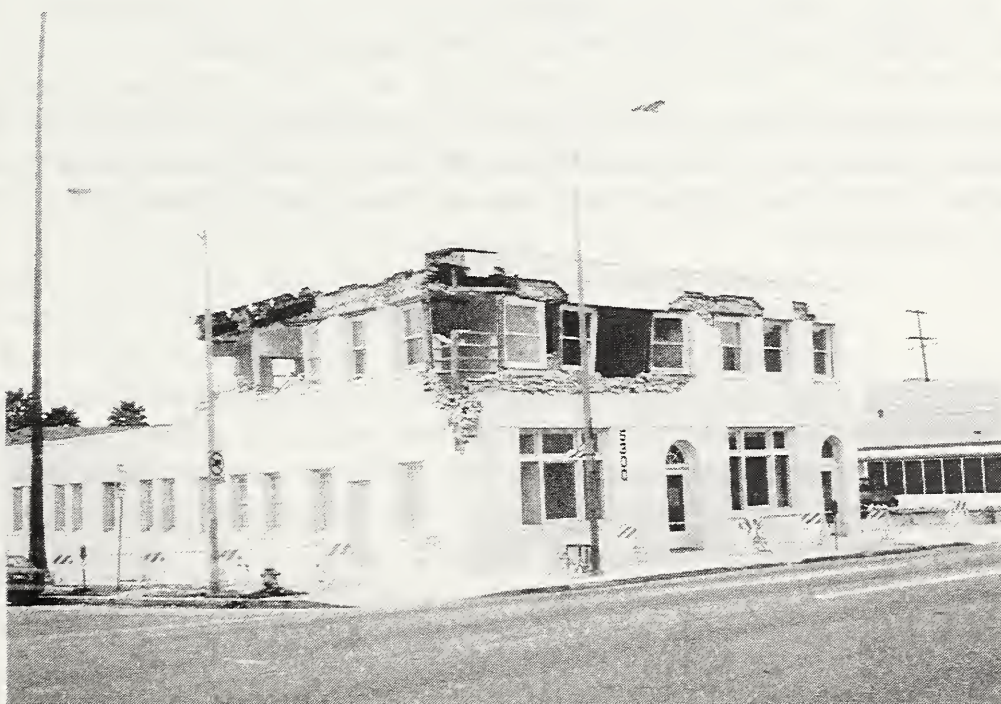
Figure 3.40 In other rehabilitated unreinforced masonry buildings, such as this two story structure in Hollywood, entire wall thicknesses were lost between rows of through-bolts.

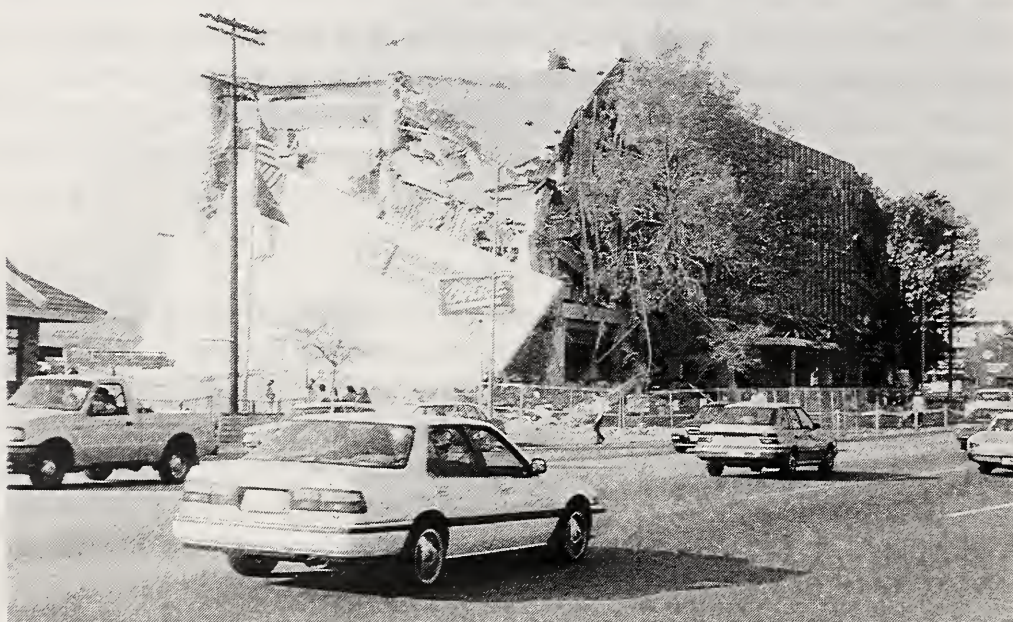
The concrete frame Kaiser Permanente office building on Balboa Boulevard in Northridge was badly damaged. The second story columns disintegrated, causing the upper stories to collapse onto the first story, which remained intact (Figure 3.41). At the ends of the building, damage to the frame caused partial collapses, but the mid-section of the building remained intact. The apparently nonstructural end walls became detached at both ends of the building and slid to the ground (Figures 3.42 and 3.43). The failure of these end walls may have contributed to the damage to the frame at the ends of the building.

Figure 3.42 Both end walls of the Kaiser Permanente building slid, partially intact, to the ground. The south wall is pictured here. Both ends of the building suffered damage to the concrete frame at all story levels, while the middle half of the building, except for the second story, remained intact.

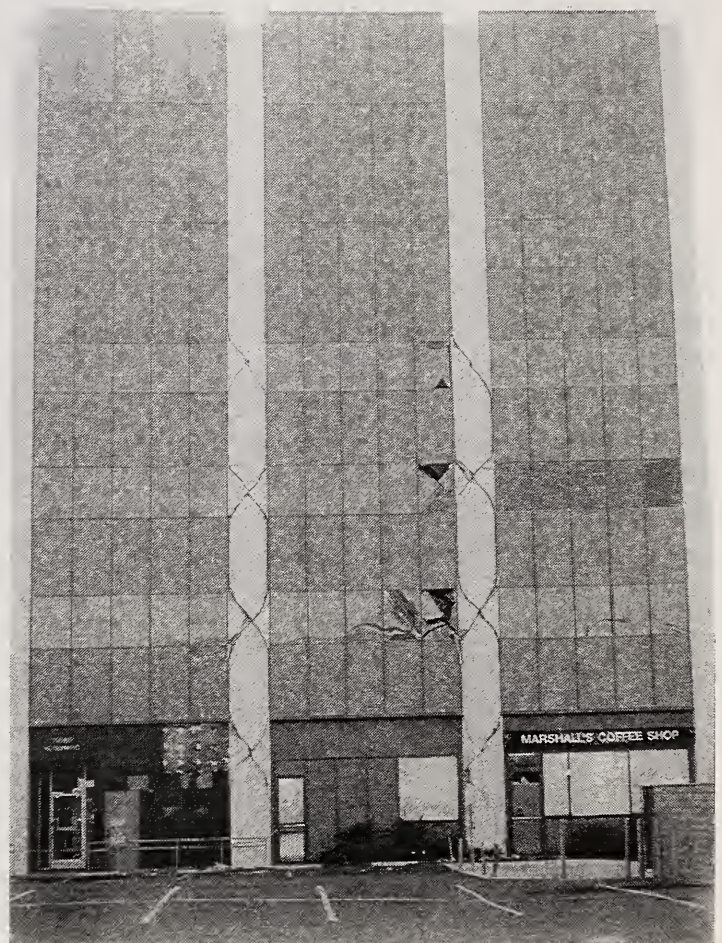
The L-shaped concrete frame Barrington Building in West Los Angeles also had damage concentrated in the second story columns (Figure 3.45). In this building, the horizontal architectural panels stiffened the lower half of the columns at each story, creating a short-column effect. The effectively shortened columns failed in shear between the windows, creating a pattern of X-cracking in the columns that diminished in severity towards the top (Figure 3.46). At the second story, the cracking was severe enough to cause a loss of vertical-load-carrying capacity; the bulging window frames indicate about a 50 to 100 mm reduction in height (Figure 3.47). The building was demolished within a few days of the quake.

Figure 3.46 The stiff infill panels of the Barrington Building effectively shortened the concrete columns, forcing all the displacement into the column sections bounded by windows. Diagonal X-cracking decreased in severity towards the top of the building.

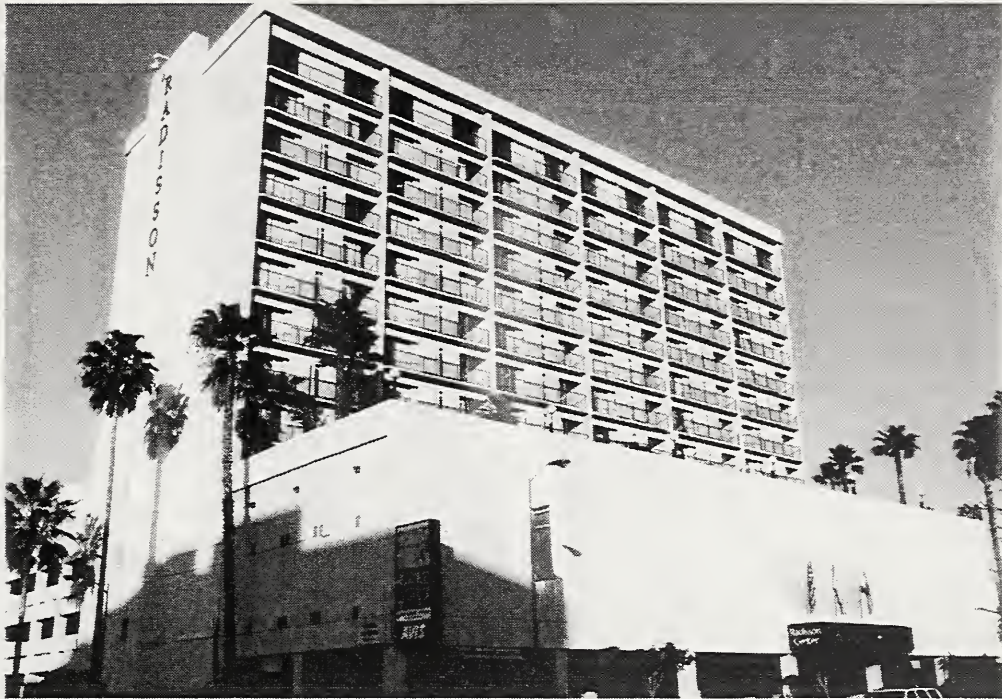
The Radisson Valley Center Hotel is located at 15433 Ventura Boulevard in Sherman Oaks (Figure 3.55). This thirteen-story concrete structure sustained serious damage to columns located at the first and fifth stories. Exterior columns which support the three-story appendage at the front of the hotel were also damaged (Figure 3.56)

Figure 3.55 The concrete Radisson Valley Center Hotel in Sherman Oaks had serious damage to the columns at the first and fifth stories.

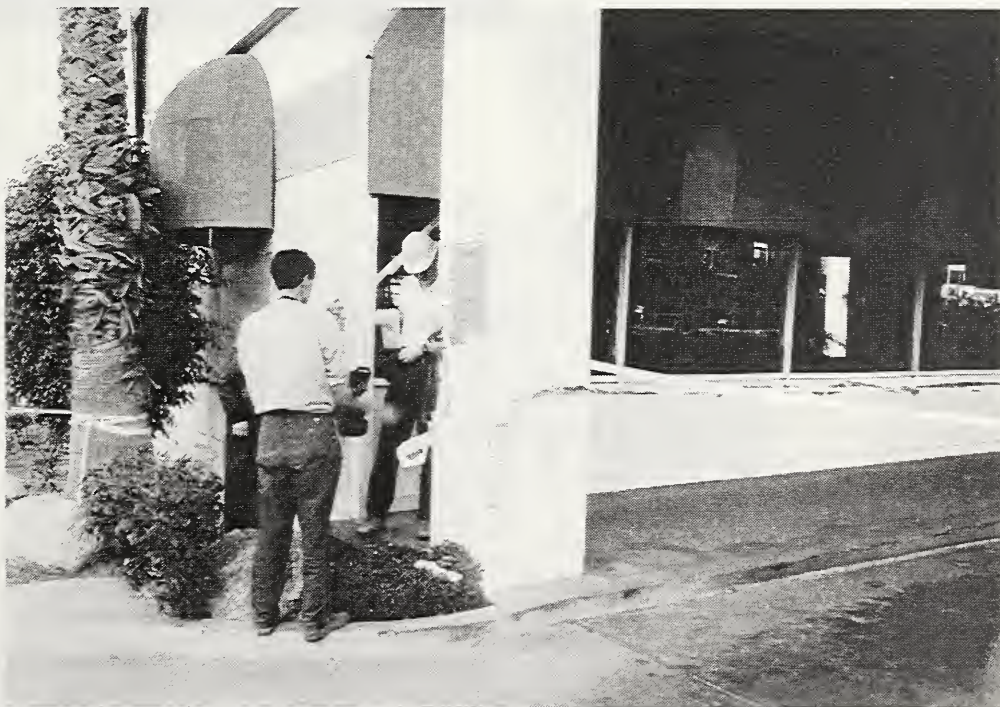
Figure 3.56 The columns supporting the three-story appendage at the front of the Radisson Hotel had serious shear cracks and related spalling.

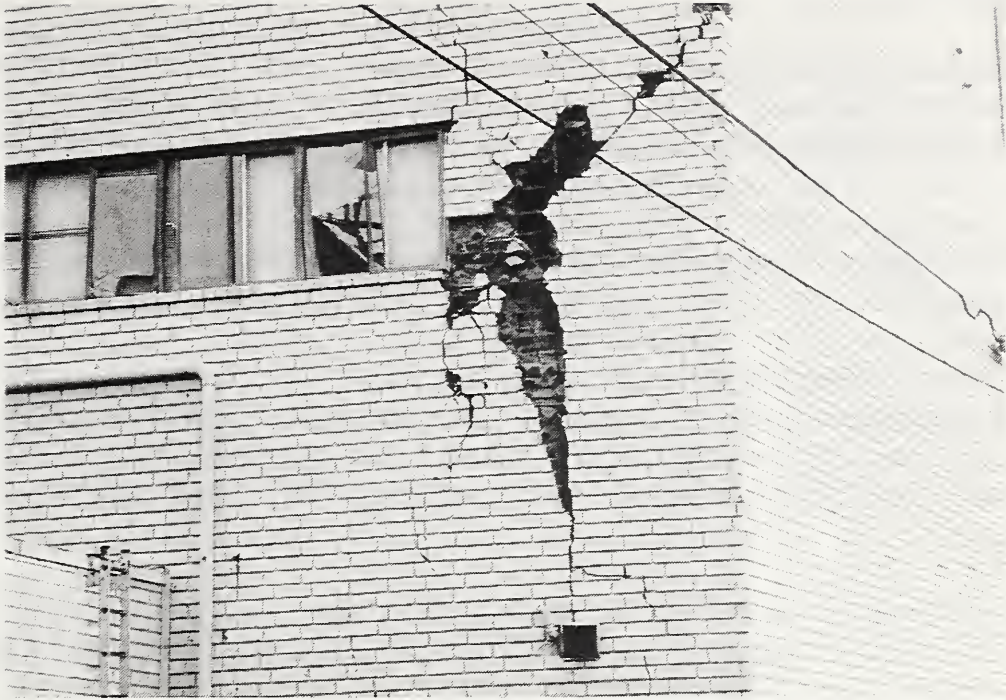
Figure 3.59 A close-up view of the damage shows the pattern of reinforcing used in the masonry facade.

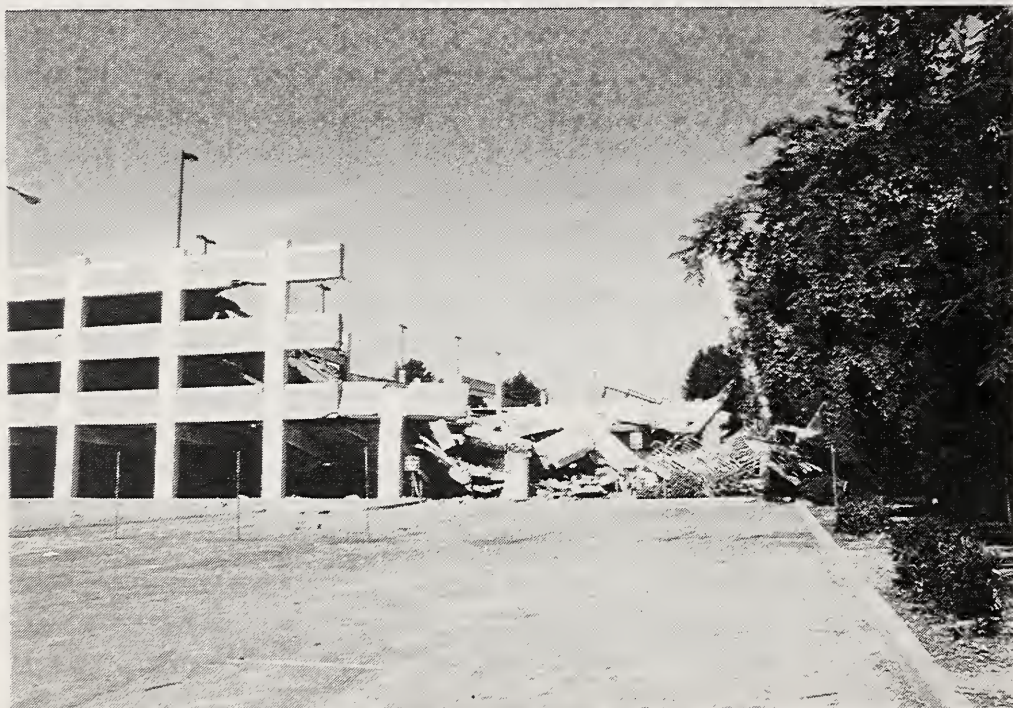
Figure 3.61 Some interior columns of the Northridge campus parking garage remained standing.

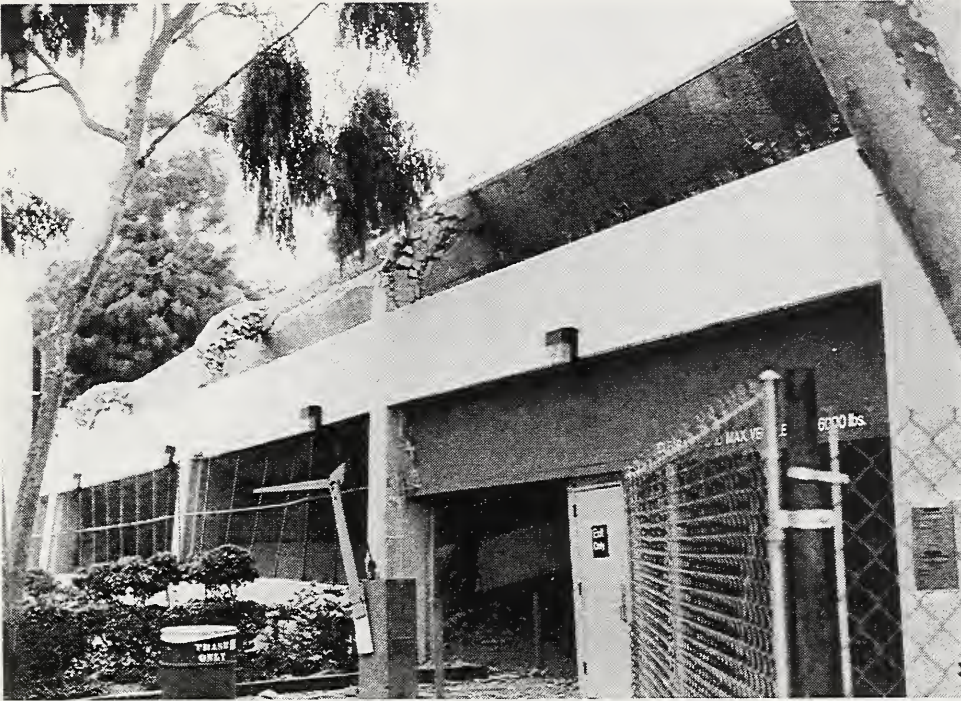
Figure 3.62 The cast-in-place concrete parking garage at the Kaiser Permanente Hospital complex in West Los Angeles collapsed in on itself. The moment frame that provided lateral resistance on the south face of the structure could not resist the out-of-plane forces apparently caused by the collapse of interior elements.

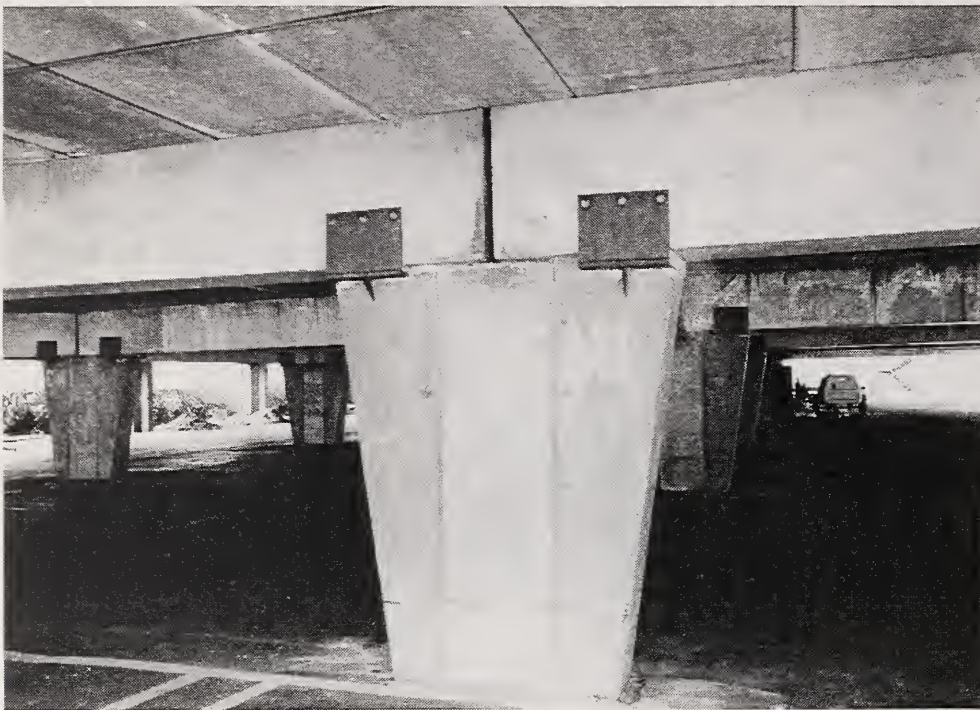
The two-level concrete parking structure adjacent to the Trans World Bank in Sherman Oaks had been seismically strengthened after suffering serious damage in the 1971 San Fernando quake. Flared extensions were cast next to the interior columns along their north-south axes (Figure 3.64), creating short wing walls supporting the precast beams. During the 1994 quake, the unrehabilitated exterior columns were badly cracked (Figure 3.65). The ramp was also heavily damaged. The interior columns were relatively undamaged.

Figure 3.64 The interior columns of the two-level parking garage at the Trans World Bank in Sherman Oaks had been seismically strengthened after it suffered damage in the 1971 San Fernando quake. The interior columns fared well in the 1994 Northridge quake.
